Manhole Inspection Summary

Manhole # S45GG_065MH

Insp Date: **3/13/08 11:31 AM**

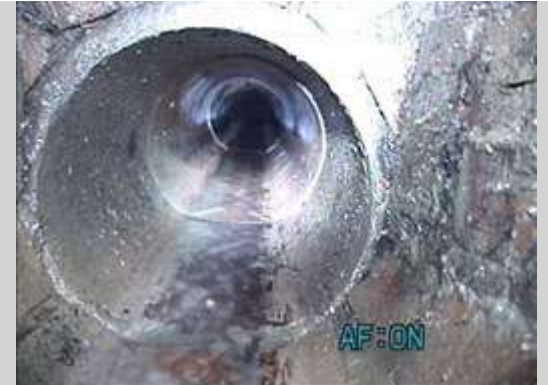
12 O'Clock Outflow

8 in. Circular Gravity Sewer
Pipe Out @ 12 O'Clock

Infiltration: **None** Pipe Seal Cond: **Sound**

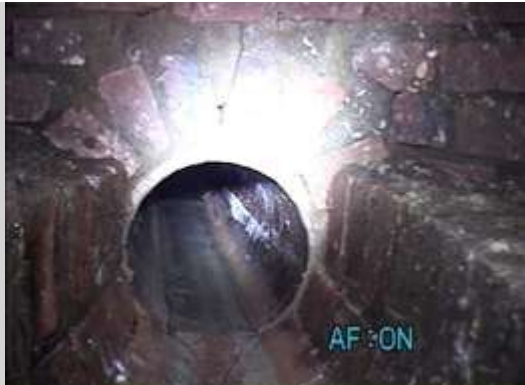
Pipe In @ 7 O'Clock

8 in. Circular Gravity Sewer

7 O'Clock Inflow

Infiltration: **None**
